# Heritage restoration

## Audley End sluice gates

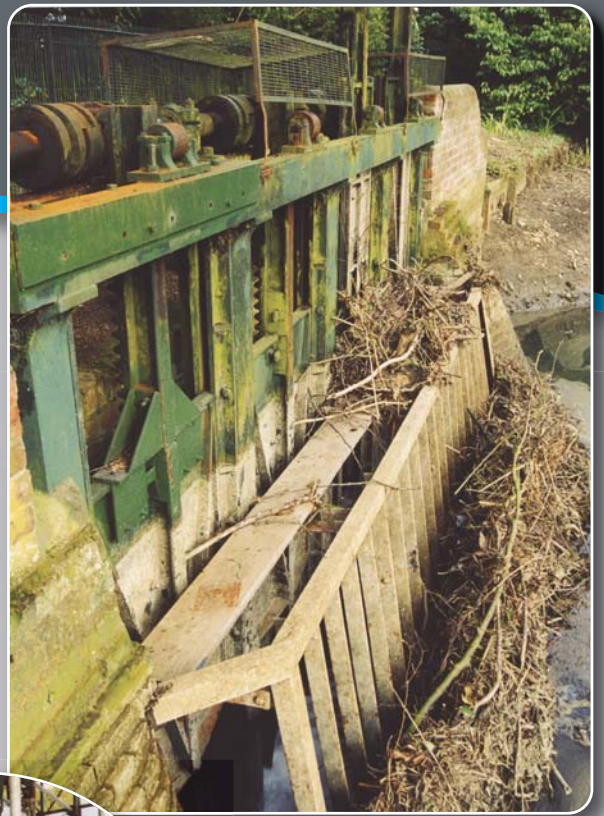
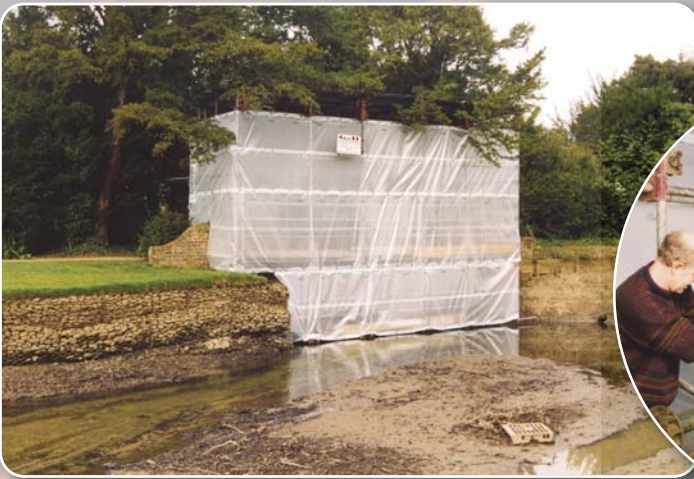
Audley End House sluice gates were found in a very distressed condition with seized barrier sections, broken gearing, main-shaft seizure and severely restricted waterway relief.

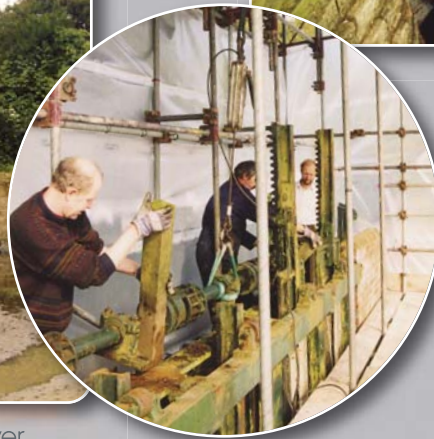
Scaffolding and weather-proofing were erected over the site to comply with health and safety regulations.

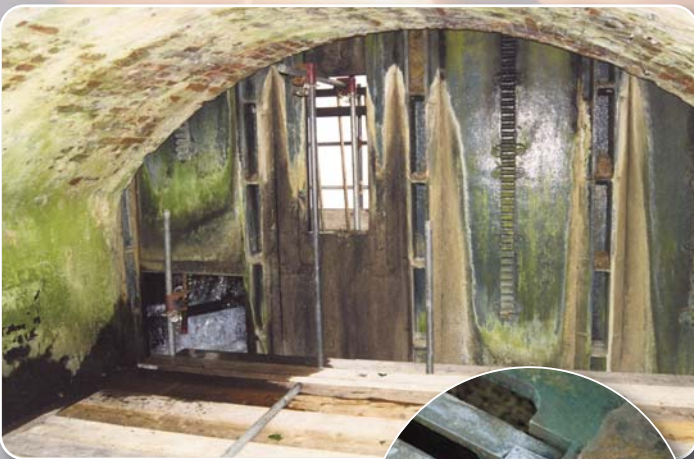
The removal of the top section of the sluice gates including gear components and downright supports.

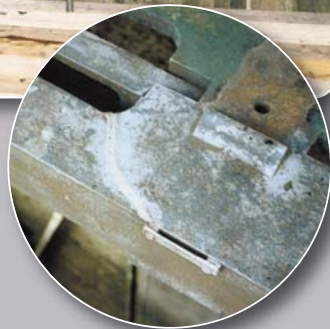
The underside of the bridge showing the scaffolding in place ready for the removal of the sluice gate mechanism. A poorly executed third-party arc weld showing extensive cracking.

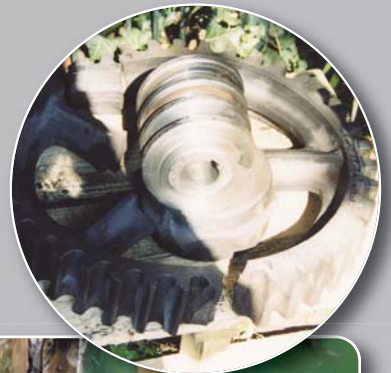
The original gearing proved to be badly damaged. New gears with improved ratios were manufactured and installed by Cast Iron Welding Services.

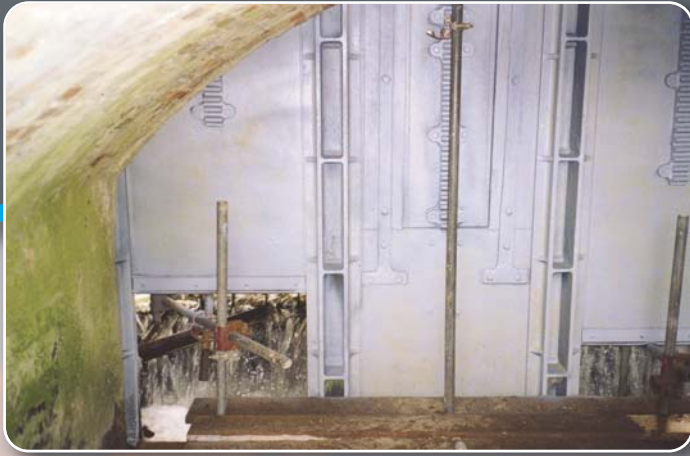
Re-fitted sluice gate section viewed from inside the bridge.

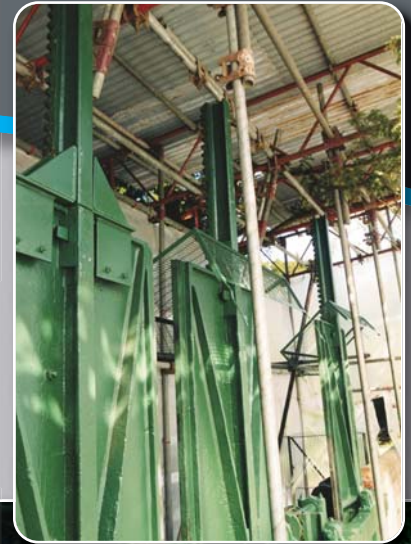
Re-fitted gearing, main-shaft and bearings. Note: the gates have been manually opened to a height of 5 meters with the aid of the newly fitted gear ratios.

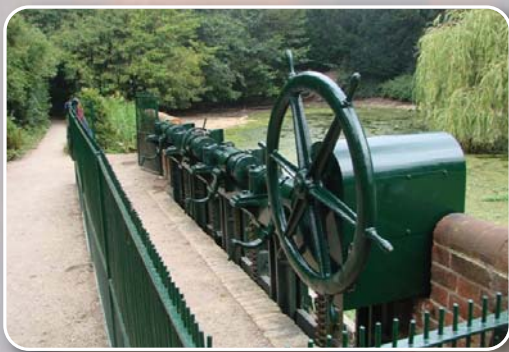
Completed sluice gates with restored mechanism and guards.

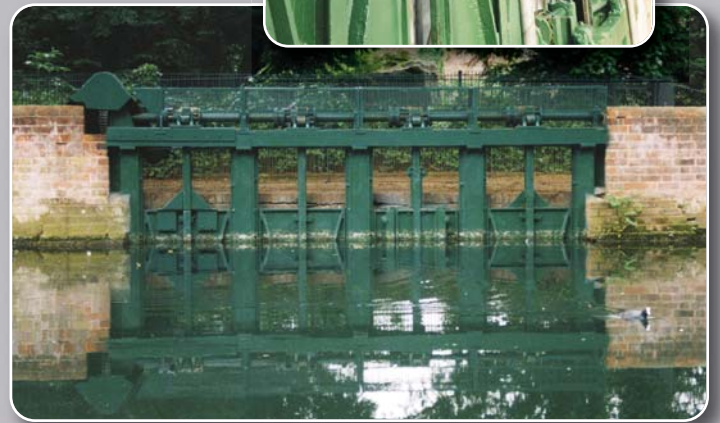
The newly finished gates viewed from the river bank opposite.

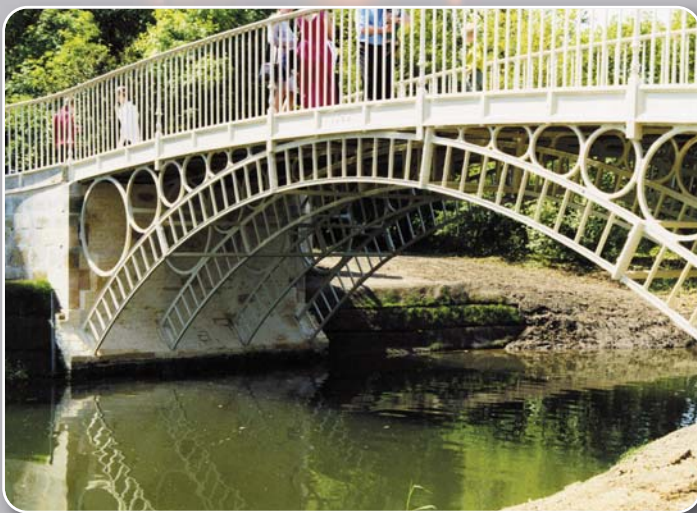
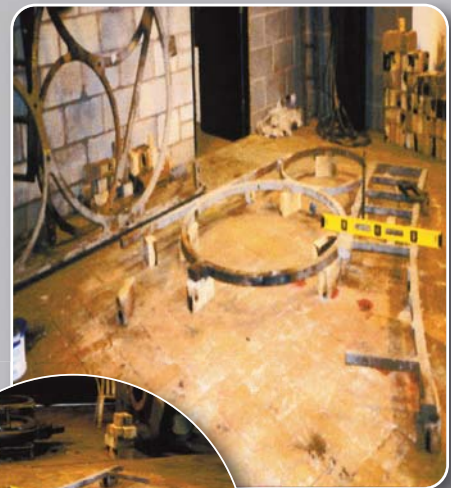
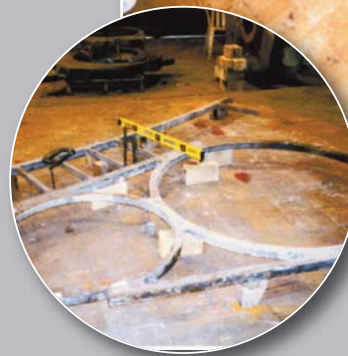
Restoration work to the bridge which dates back to 1802 required the repair of over 160 fractures using material identical to the parent metal.

The bridge was dismantled and the sections taken to our workshop. Each was stripped and inspected before restoration.
