Cast Iron Welding Services were asked to restore a number of decorative cast iron lamp standards on Brighton sea front. The lamps and columns had been removed leaving only the bases.

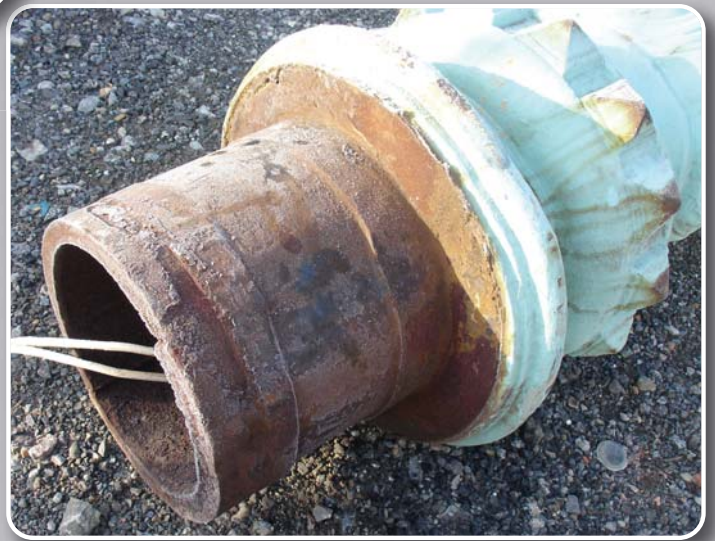
Spigots that locate the columns into the base's were worn, allowing the the lamps to rock dangerously.

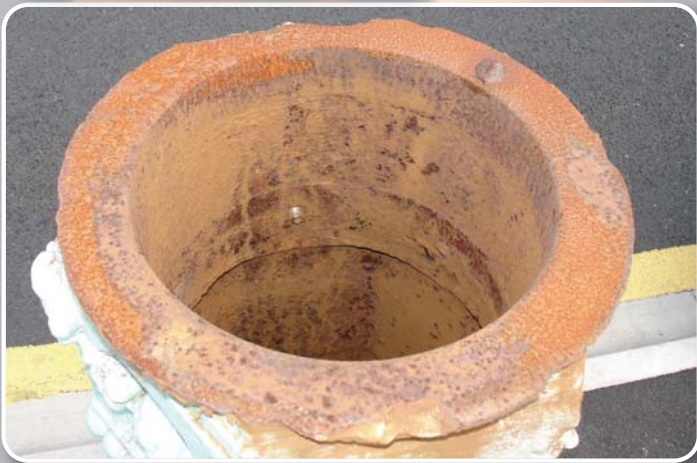
The base which receives the column is eroded and will require reaming out to accept the rebuilt and machined spigot.

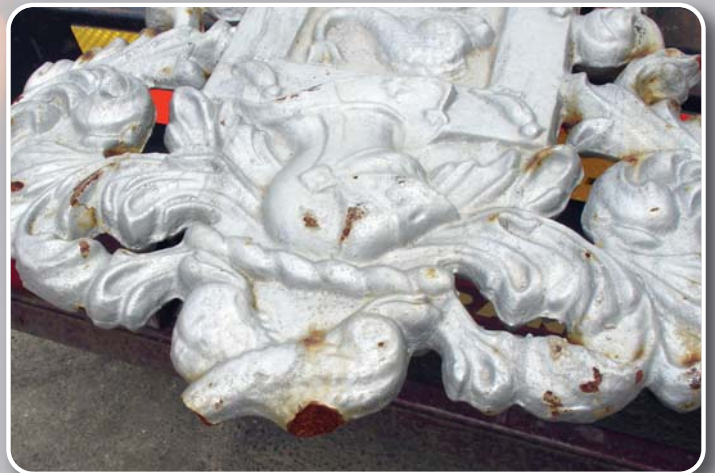
Each of the castings was assessed for damage and subsequently repaired at our workshops.

The castings were shot blasted, any damaged detail was built up with weld and re-contoured to original before being treated to a liberal coating of primer.

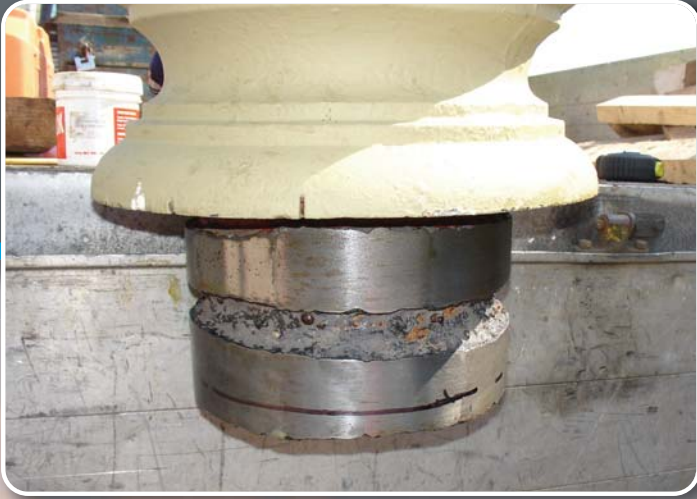
The column spigots were built up with gas fusion weld, and along with the mounting face, re-machined. The finished castings were then returned to site.

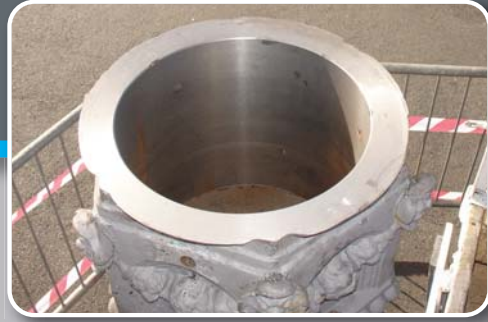
The finished lamp base.

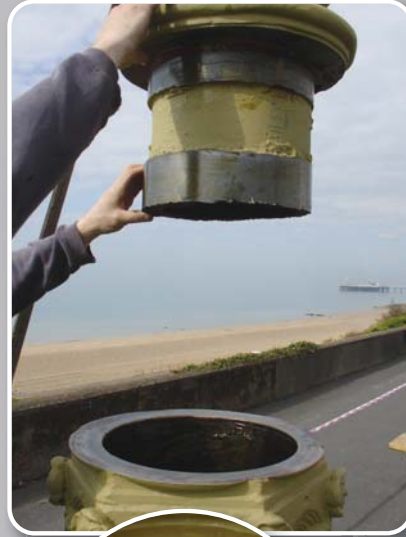
The column is lifted into position and the spigot is dropped into the base.

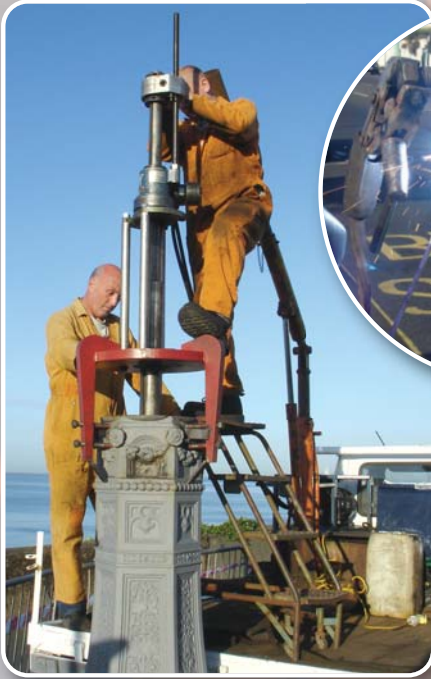
A specially designed reaming cradle was secured around each lamp base to aid accurate positioning of the reaming tool.

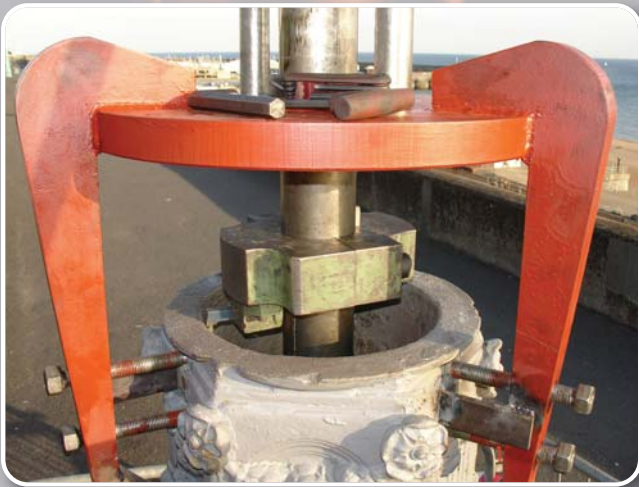
The reaming tool gets to work.

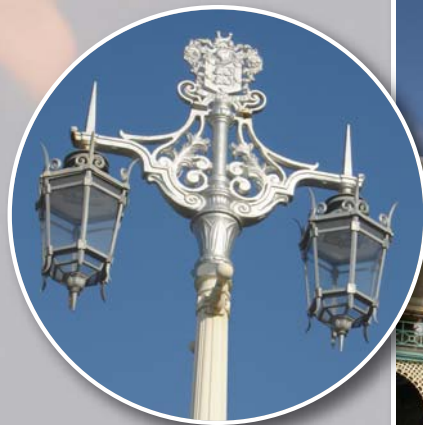
The finished job, the stored and re-painted lamp standards.
