Heritage restoration Harewood House Gates

Harewood House, Leeds is home to the Queen's cousin, the Earl of Harewood. Recently a vehicle was in collision with the main gates causing damage and distortion to the metalwork.

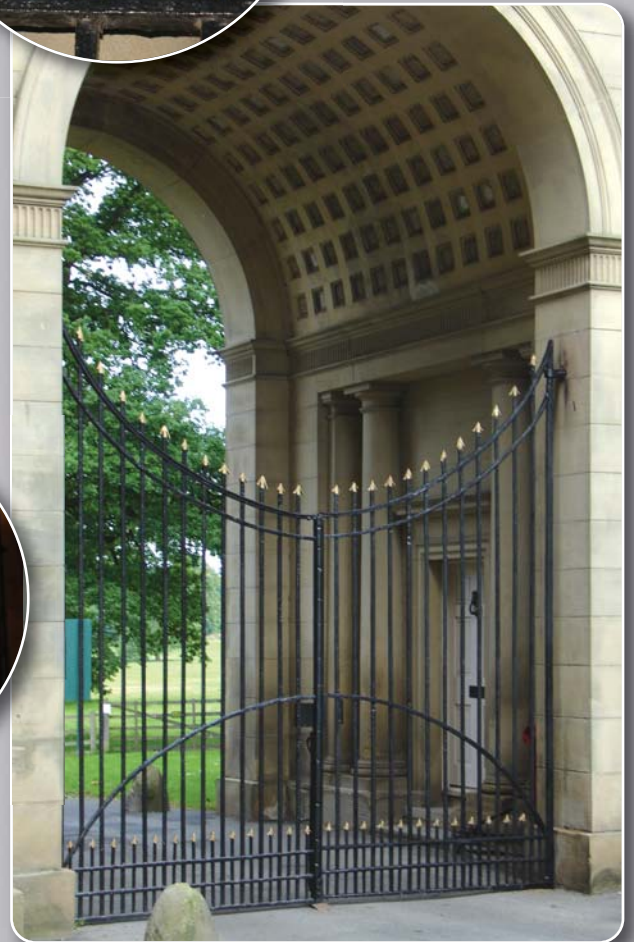
The collision has distorted the metalwork, loosening the leaded joints.
