Moseley Road Public Baths are home to the last surviving washing baths in Birmingham. Cast Iron Welding Services were asked to restore the boiler-house chimney head when after inspection, the Victorian castings were found to be suffering severe deterioration.

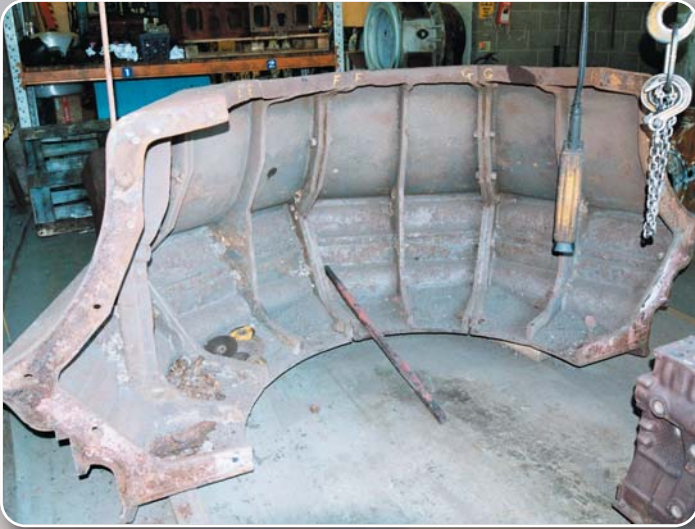
The chimney segments are separated ready for cleaning and checking.

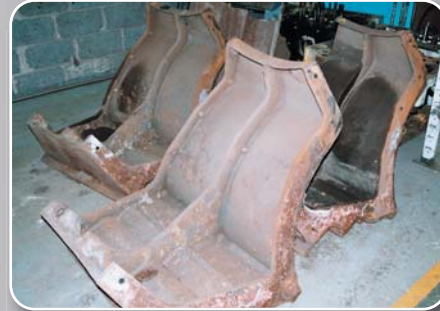
A fracture travelling vertically full length of the cast section shown internally and externally.

fractures leading from the bolt interfaces travelling horizontally and vertically, shown internally and externally.

Fractures are ground out ready for filling and grinding back to original shape.

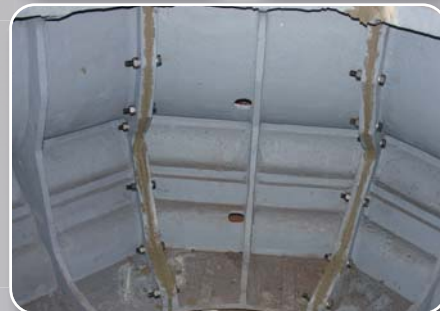
Internal view of finished welded sections with fireclay packing between the flanges.

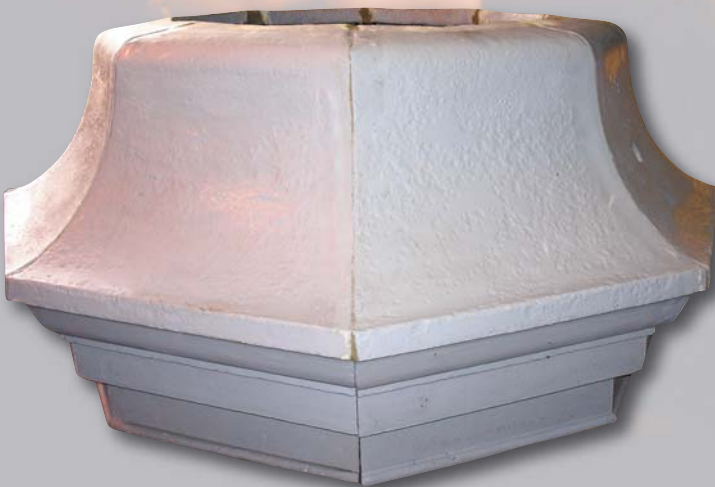
The restored segments are primed and bolted together ready for transport back to Moseley Road.

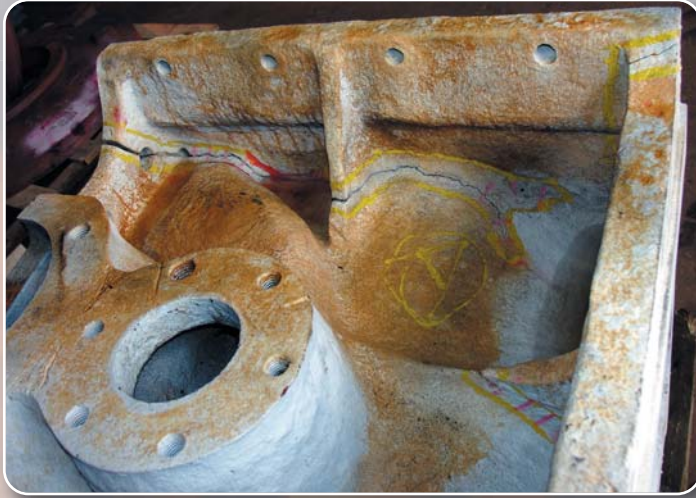
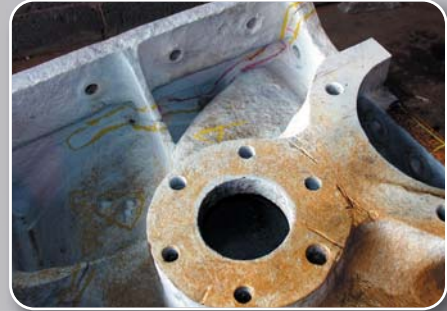
Block received in cracked and distressed condition. Cracks highlighted by M.P.I. crack detection.
