Veteran, vintage and classic motor vehicle casting repairs

For the restoration of cast iron components for steam engines and vintage vehicles

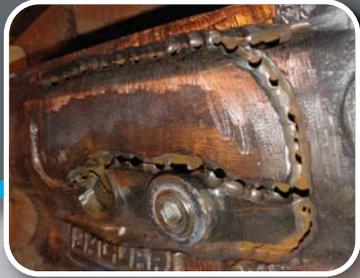
Jaguar 3.8 Litre block with water jacket corrosion damage.

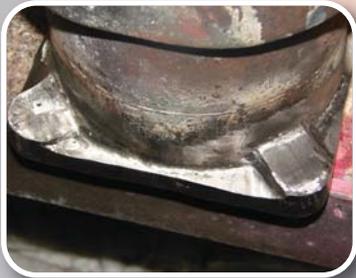
This veteran cylinder/head casting had suffered broken flanges. Both flanges was rebuilt with gas-fusion welding and machined back to standard specification.

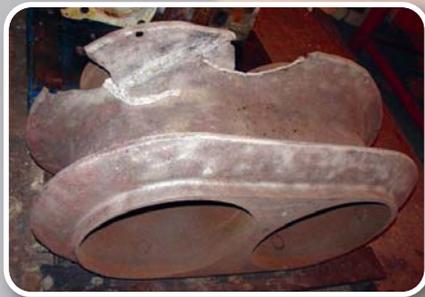
This double chimney stack casting was broken and had been poorly repaired. We replaced the missing sections of the casting, blending the new metal into the original and gas fusion welded the cracks. The stack is now serviceable again.

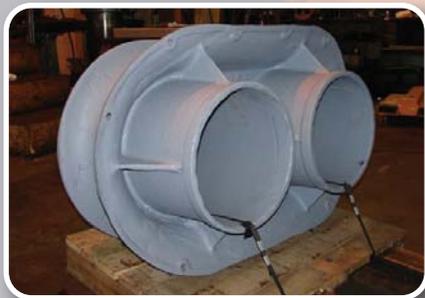
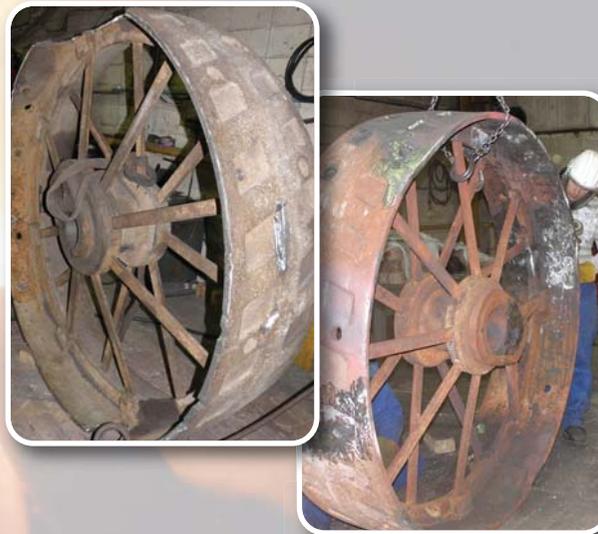
This traction engine wheel has suffered extensive cracking with large sections missing. The internal wrought iron supports were checked and re-welded into place using the gas-fusion process. Patterns were made for casting new sections from material of the same chemical analysis and welded into position.

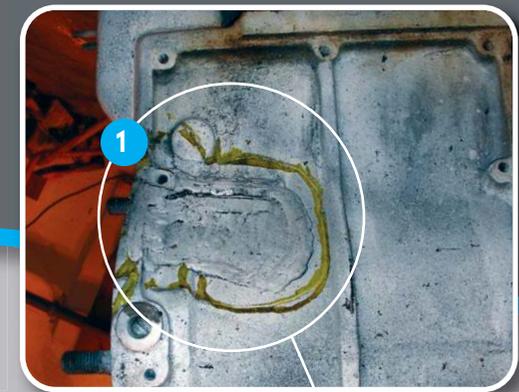
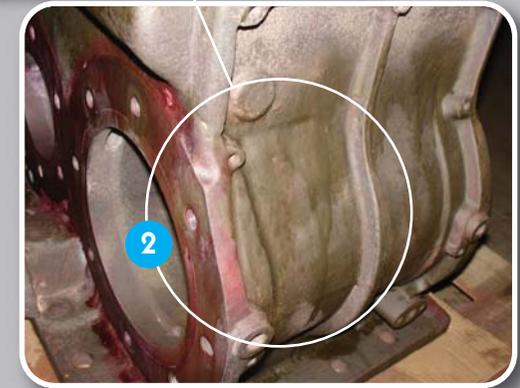
- 1 The heat from a poor arc-weld repair on this cylinder block has caused hardened areas and several horizontal cracks leading from the weld deposit. This poor weld has exacerbated the repair process. A virgin fracture would have been much simpler to gas fusion weld.
- 2 The hole adjacent to the repair on the bolting face had to be gas fusion welded and drilled. Picture 2 shows finished repair ready for fitting after testing.
